# Dielectric behavior and physico-chemical properties of 60 kV HV crosslinked polyethylene under long-term electrical aging

This study focuses on the study of long-term electrical aging effects on dielectric behavior of cross-linked polyethylene (XLPE) used as insulation in high voltage cables. For this reason, we have performed long-term electrical aging tests on full size of HV 36/60 kV XLPE cable samples at three voltage levels ( $U_0 = 36$  kV,  $2U_0 = 72$  kV and  $3U_0 = 108$  kV) during 680 hours. The studied properties are partial discharge threshold, dielectric loss factor, relative permittivity and transverse resistivity. Besides, physico-chemical changes were assessed using Fourier Transform Infrared Spectroscopy (FTIR) and X-ray diffraction (XRD). In addition, complementary diagnostic measurements, including mechanical characterization and visual observation analysis are carried out in the end of this paper. The obtained results illustrate that examined properties are widely affected by long-term electrical aging. The increase in partial discharges and dissipation factor depending to the voltage level and the aging time and the decrease in partial discharge threshold

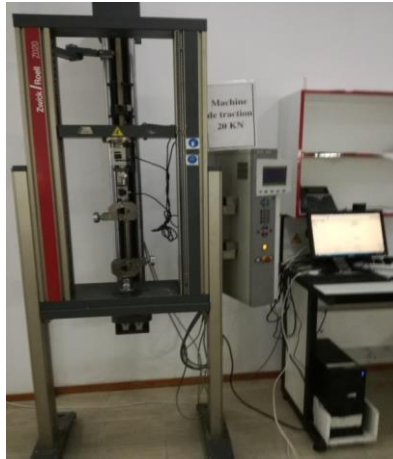
**Figure 4.** Uniaxial tensile testing machine.

The mechanical behavior is characterized by the measurement of the elongation at break and tensile strength using a tensile machine (Zwickroell, Germany) (Figure 4) in accordance with IEC standard [11]. This machine has an adjustable drive to perform the tests at controlled speed. It is equipped with two jaws; one fixe and the other mobile, as well as force sensors to determine the force required to break the specimen. The machine is controlled by software where the parameters can be entered by computer. The speed of the mobile jaw is set at 25 mm/min.
